**Inspection Date:** 07/24/19  
**Project Number:** 19-001  
**Inspector:**

**June Inspection Report for:** Roosevelt Channel Phase 1

**Site Location:** Roosevelt Channel Phase 1 is located in western Sioux Falls; phase 1a is located between 26<sup>th</sup> and 32<sup>nd</sup> Street to the west of South Sertoma Avenue; the site is approximately centered at 43°31'22.44" N, 96°49'7.57" W. See reports on *Roosevelt Channel Phase 1b* for information dealing with the portion of channel phase 1 located to the east of South Sertoma Avenue.

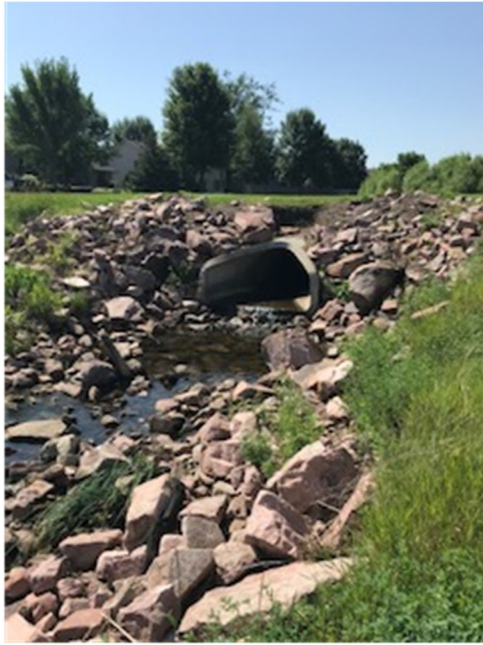
1. Channel Erosion on the northwestern, southwestern, and southeastern channels were observed (Figure 1)
2. Buffer zone has been mowed
3. Common Reed (*Phragmites australis*) present.
4. Purple Loosestrife (*Lythrum salicaria*) present

Figure 1: Erosion occurring along the southwest channel

- Spray thistles and other weeds with Platoon herbicide
- Spray Common Reed and Purple Loosestrife with Habitat herbicide
- Repair erosion along the named channels and install proper erosion control structures.

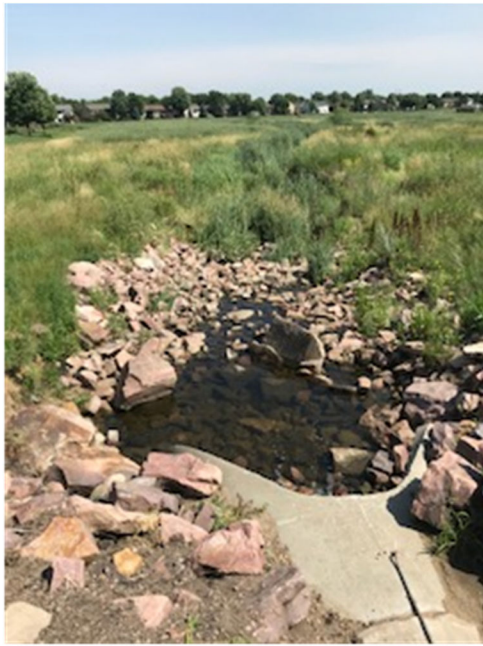
Figure 2: Erosion along the Southeast Channel

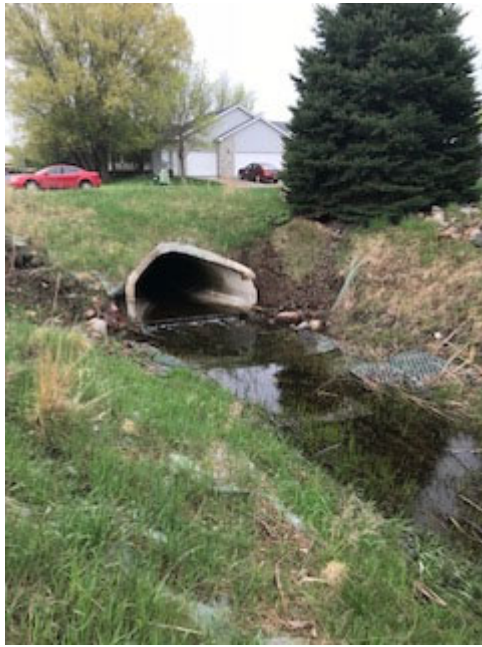
Figure 3: Erosion around culvert and channel of SE channel
