**Inspection Date:** 07/24/19  
**Project Number:** 19-001  
**Inspector:**

**June Inspection Report for:** Roosevelt Channel Phase 1

**Site Location:** Roosevelt Channel Phase 1 is located in western Sioux Falls; phase 1a is located between 26<sup>th</sup> and 32<sup>nd</sup> Street to the west of South Sertoma Avenue; the site is approximately centered at 43°31'22.44" N, 96°49'7.57" W. See reports on *Roosevelt Channel Phase 1b* for information dealing with the portion of channel phase 1 located to the east of South Sertoma Avenue.

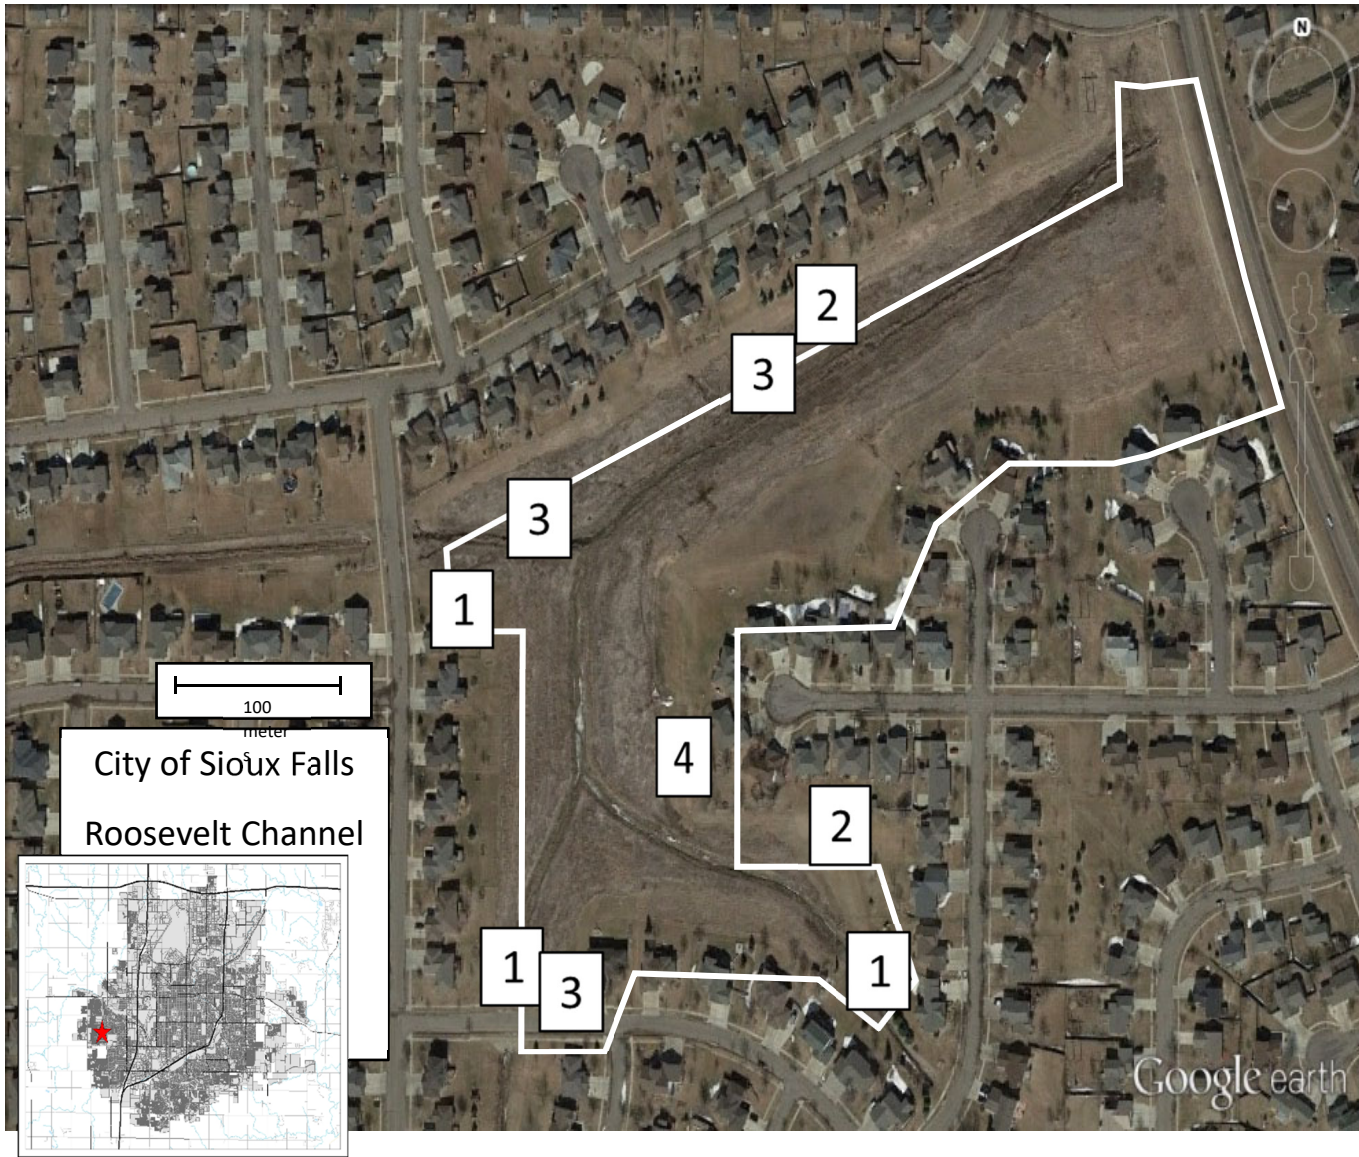
1. Channel Erosion on the northwestern, southwestern, and southeastern channels were observed (Figure 1)
2. Buffer zone has been mowed
3. Common Reed (*Phragmites australis*) present.
4. Purple Loosestrife (*Lythrum salicaria*) present

Figure 1: Erosion occurring along the southwest channel

- Spray thistles and other weeds with Platoon herbicide
- Spray Common Reed and Purple Loosestrife with Habitat herbicide
- Repair erosion along the named channels and install proper erosion control structures.
